Chance Helical Piles Save Waterfront Home from Hurricane

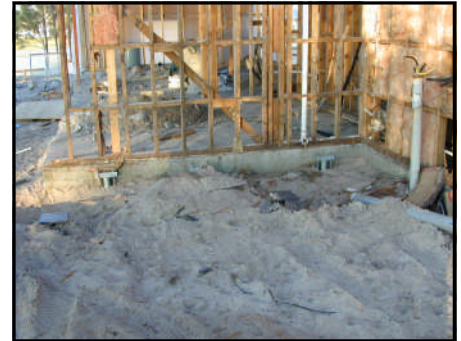
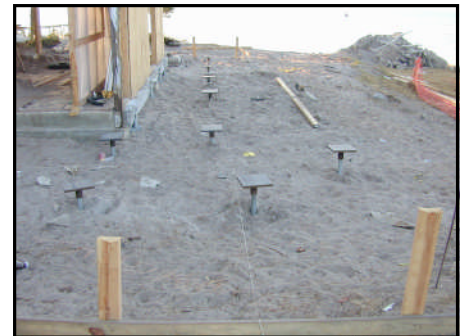
During Construction:

The Mazenko residence is a bay front home in the Pensacola area that took the brunt of Hurricane Ivan in September of 2004. The home underwent a major renovation and expansion in late 2000. The original home stood on a shallow foundation. In order to obtain a permit for the renovation the structure had to have a pile foundation to bring it in compliance with the current building codes. James J. Mallett, P.E., chose Chance helical piles to underpin the existing turndown slab construction and existing column footings. The ability to work in low overhead situations allowed the installation of helical piles while keeping the floor above intact.

The use of helical piles as new construction piles for the addition to the house allowed a deep foundation system to be installed with small, readily available equipment without worrying about noise or vibration damage to nearby homes. There was also no time and expense of cleaning up and disposing of augered spoils from an augercast operation. At the time, helical piles were the best solution to a difficult construction problem.

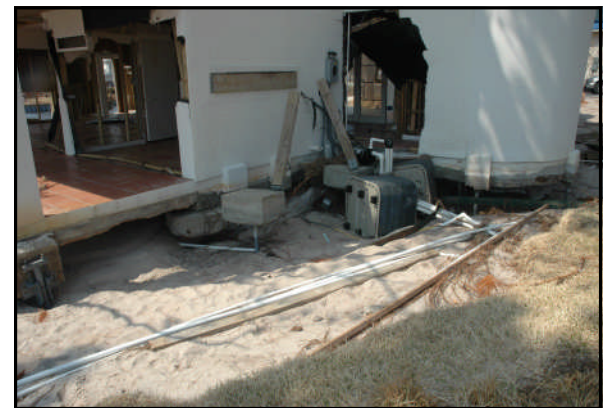
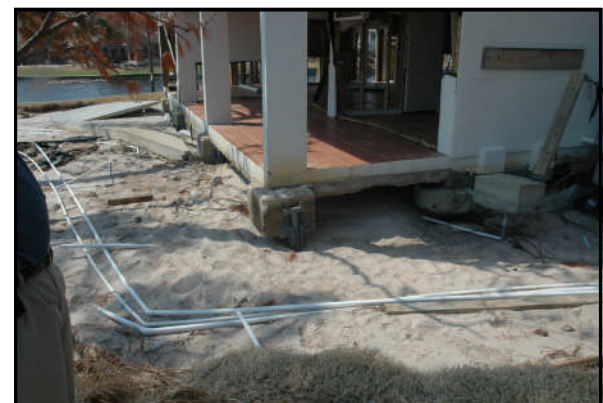
After the storm:

Now, after taking a direct hit from a Category 4 hurricane, the Chance helical piles were tested and proved to be the best solution. The Mazenko residence came through the storm intact without major structural damage while most neighbors are left wondering how to rebuild. The massive storm surge undermined the slab and footings of the renovated structure but the helical piles held the structure up and kept the damage to a minimum. After a backfilling and grouting operation to fill the voids left by the storm surge, this residence will soon be occupied long before other structures will be rebuilt.
